Integrating structural research activities and field experience with engineering education

Tamas BALOGH¹ and Zoltan ORBAN²

¹ University of Pécs, Pollack Mihály Faculty of Engineering and Informatics – Department of Structural Engineering

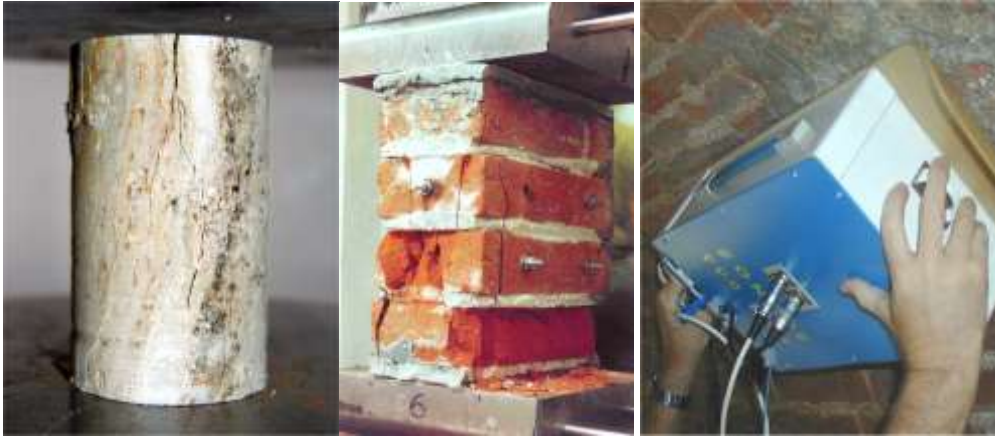
Figure 1. Examples for laboratory and in-situ diagnostic procedures. From left to right: compression strength test of a stone core sample, compression strength test of bricks, radar survey on an arch.

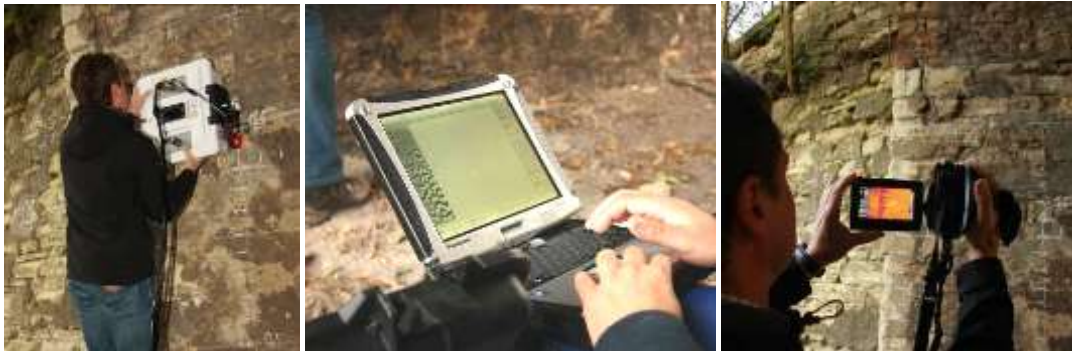
Figure 3. GPR and infrared thermography testing on stone arch bridges.

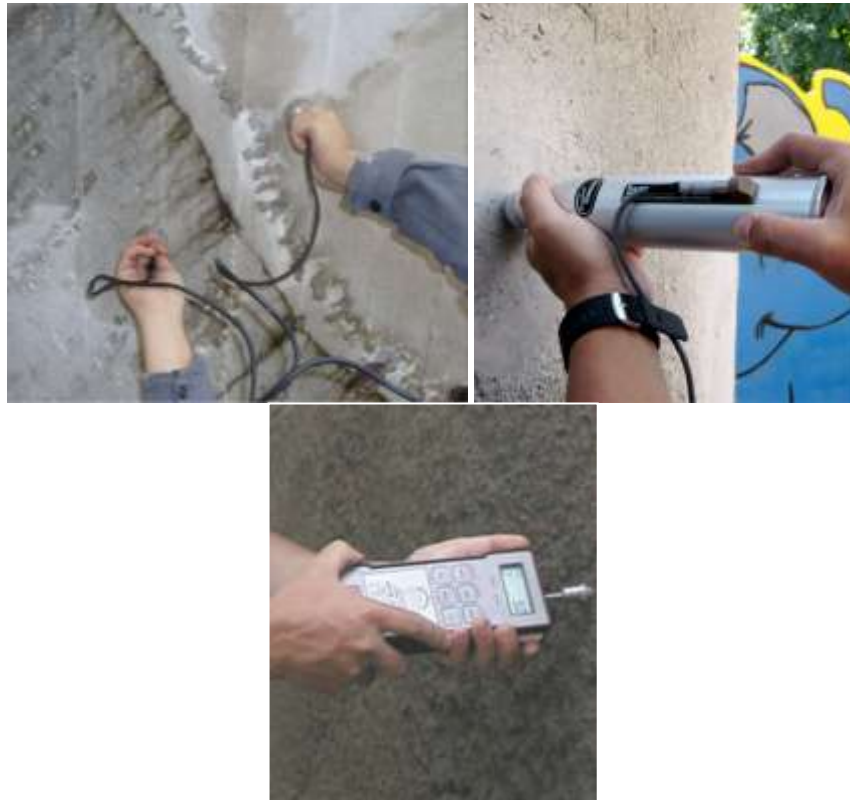
Figure 5. Site tests on real rehabilitation projects. From left to right: ultrasound test, Schmidt-hammer hardness test, penetration.

During our research laboratory tests are carried out on specimens and site tests on structures in conjunction with real rehabilitation projects. As a result of research guidance will be developed for test procedures for the quality control of rehabilitation measures. Besides the description of various test methods guidance will be provided on the optimal selection of the number of measurements, measurement locations and timing.

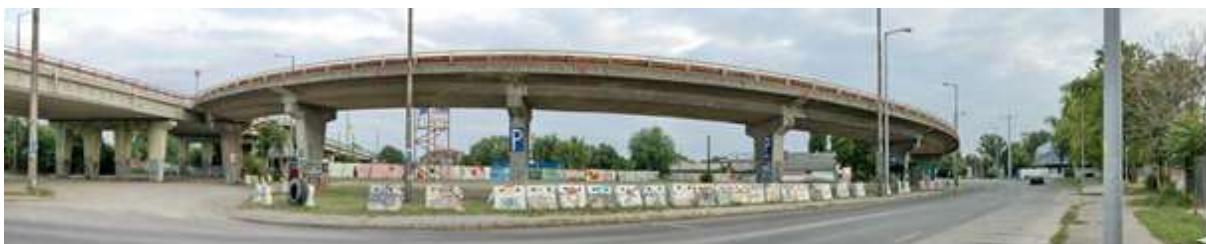
Figure 6. Side view of the curved bridge.

In 1973 a single-lane bridge was built to decrease the traffic volume of the traffic junction that leads to the overcrossing. The structural system of the bridge is a 9-span Gerber made of reinforced concrete, having a full length of 137,23 m and direct connection to the overcrossing bridge. To avoid the differential soil settings the bridge was designed as a statically determined structure. The pillars supporting the articulated, fixed and the moving joints are on the superstructure. The final width of the bridge cross-section is 7,50 m, the width of the traffic lane is 6,50 m and the two edge beams are 0,50 m wide. The maintenance works of the bridge were not sufficiently carried out for almost 30 years of service. During this period only minor repair work were made. There was a larger intervention in the year 2000. During this intervention a pavement reconstruction was made. Because of these circumstances and the environmental conditions the overall condition of the structure continuously degraded. The signs of the degradation processes were the following: concrete cover spalling, corrosion of the rebars, leaching. Overall, the structure was in a bad condition and made the renewal works imminent.

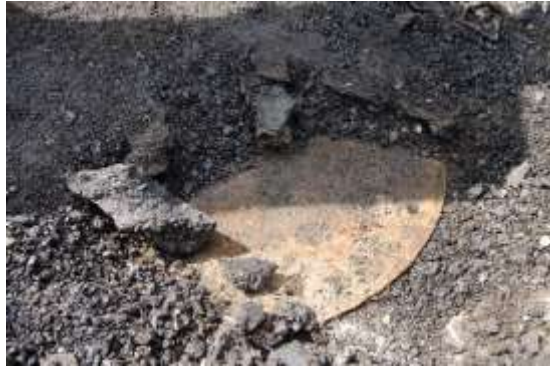
Figure 8. Sinkhole covered with metal plate under the pavement layers.

Four of the eight pillars had drainpipes, however there weren't any sinkholes on the pavement. After the minor excavations on the pavement level we recognized that the sinkholes are disassembled and the drainpipe connections were covered by a metal plate. At the renewal works in the year of 2000, after the disassembling of the sinkholes and the covering the pavement layers were built on this metal covering completely closing the drainage system.

After the pavement excavations the causes of the corrosion and the extent of the structural degradation was known. The pavement reconstruction works have modified the complete drainage system of the bridge. Before the pavement reconstruction the drain pipes deflected the gathering water on the pavement level. With this modification the whole amount of water which gathered on the bridge pavement had to move to the lower part of the bridge to a sinkhole at the abutment. This amount is more than a sinkhole at the abutment could let through and the flowing water could penetrate into cracks and the gaps on the curved edge beam. This effect was the main cause of the degradation and if this process continued it would have led to a serviceability and durability problem.

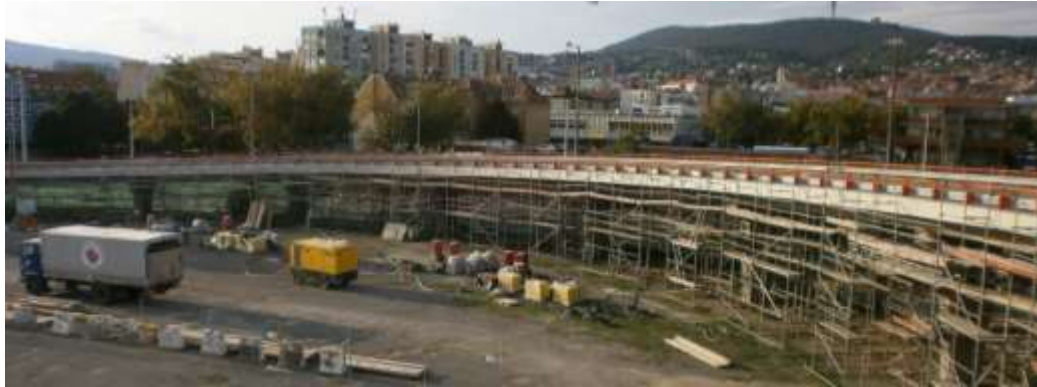
Figure 9. The bridge during the reconstruction works.

From the summer of 2012 to the summer of 2013 till the start of the renewal works there was a speed limit of 30 km/h on the bridge. The works had started in July, 2013. After building the scaffolding several work phases started on the pillars and on the superstructure too. These work phases were the following: the demolition works of the full pavement structure and the loosening corroded elements of the pillars and the superstructure. After the demolition works of the loosening parts of reinforced concrete structures the next phases were the protection of the rebars and the reprofiling with shotcrete.

The renewal works had focused on the key working phase: the rehabilitation of the expansion joints, the drainage system and the pavement. After the full demolishing of the old pavement layers and preparing the raw concrete surface the building of the complete new drainage system was the following. The new drainage system consists of new sinkholes, drain pipes, pavement drainage channel. The new expansion joints were built on the old ones which stayed inside the structure giving a good foundation for the new ones. After the asphalt paving, the protection of the reinforced concrete elements against environmental effects (salt corrosion, weather), the last phases were the placing of guard-rails and the complete painting of the structure.

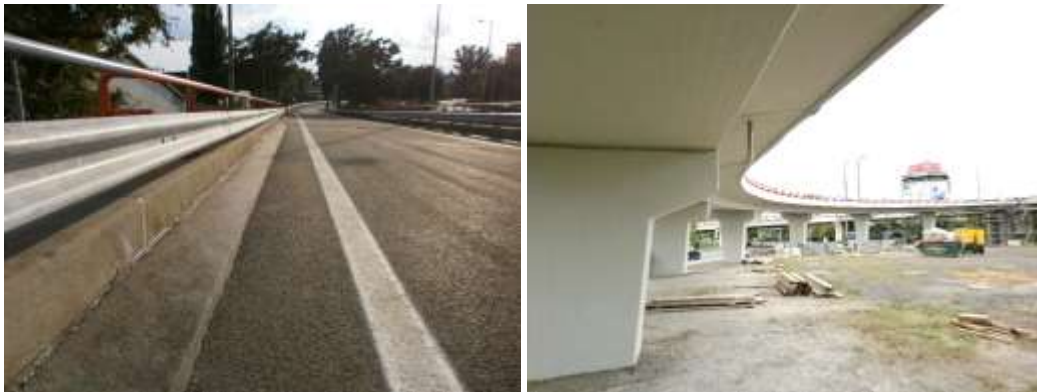
Figure 10. The bridge after the reconstruction works.

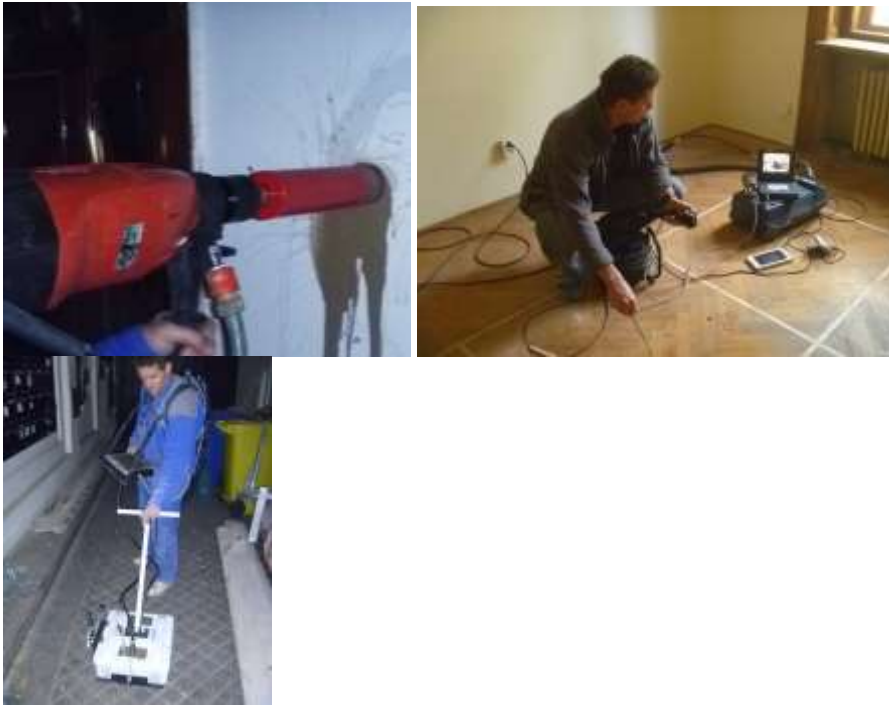
Figure 12. Diagnostic assessment of the building, from left to right: core drilling, videoendoscopy, radar survey.

For determining the strength of the structural walls different diameter core drilling needed to be made on different storeys. In laboratory the cores were tested with compression testing machines after laboratory preparation. In the basement there was a bunch of bricks weren't built in. Samples made from the bricks in the laboratory for standard compression tests. For the hidden structural elements and defects videoendoscopy was used through pre-drilled holes in the walls.

For non-destructive assessment of the walls and floors we used a georadar system which is widely used during geological and geophysical surveys. The aim of this type of assessment method was to get a view about the structural inhomogeneity and specify the areas which have different condition than the other areas. The radargrams from the georadar surveys showed the arches between the beams, the exact location of the beams, the layers over the arches and the wall sections under the prussian vault floors.

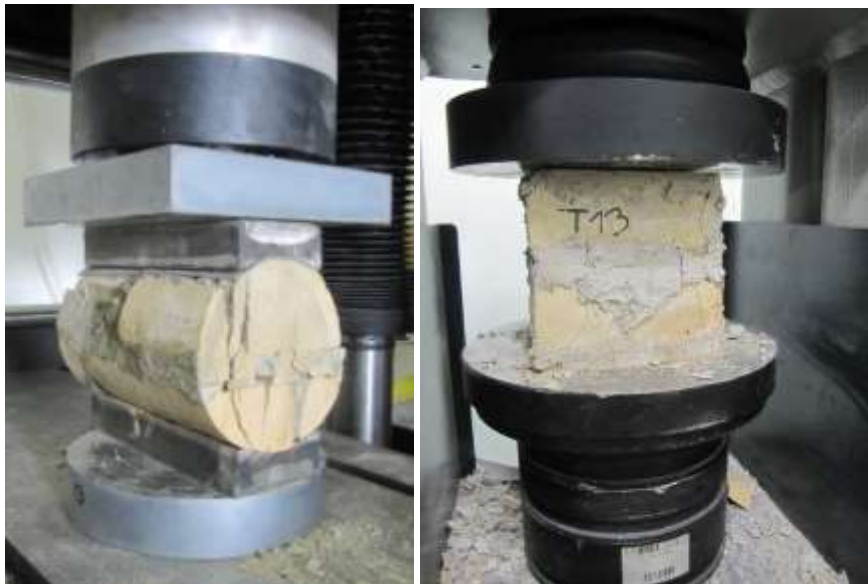
Figure 13. Laboratory tests on samples.

The following materials were tested: the individual bricks from the basement, the different diameter drilled cores. After laboratory preparation the strength properties were determined. From the drilled cores mortar samples were separated. These samples were tested in compression testing machines to obtain the strength of the material. After the compression tests the remaining material parts were examined by a scanning electron microscope (SEM) to obtain further data about the material composition.
